Manhole Inspection Summary

Manhole # S35UU_004MH

Insp Date: 1/11/07 1:28 PM

Location Address: **2743 GUILFORD AVE**

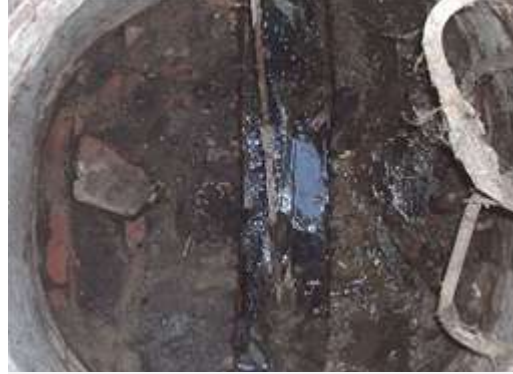
Top View

Evidence of surcharge - Bench debris.
Channel debris.

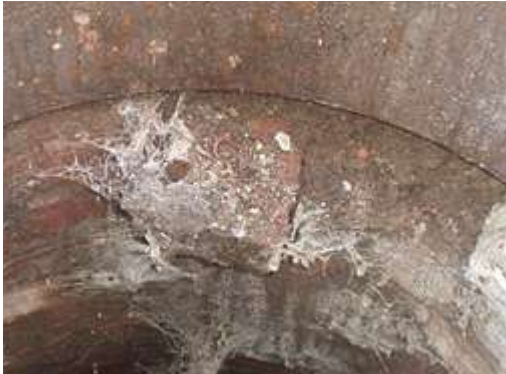
Defect

Frame leaks. Frame offset. Adjustment
deterioration, loose brick and infiltration.

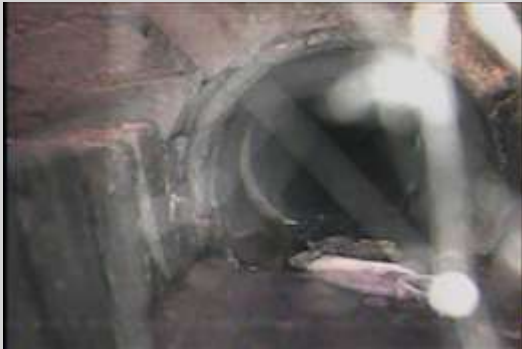
8 in. Circular Gravity Sewer Pipe Out @ 12 O'Clock

Deposits: ☐ None ☒ **Mud** ☐ Sludge ☒ **Debris** ☐ Grease

Silt Depth: **0** (in.) Deposits Extent: **Light**

Infiltration: **Evidence** Pipe Seal Cond: **Unknown**

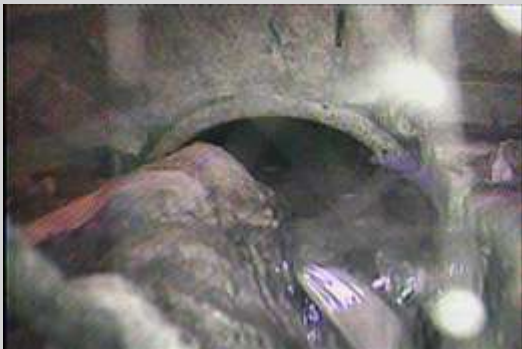
8 in. Circular Gravity Sewer Pipe In @ 6 O'Clock

Deposits: ☐ None ☒ **Mud** ☐ Sludge ☒ **Debris** ☒ **Grease**

Silt Depth: **6** (in.) Deposits Extent: **Heavy**
